WRAP (Whole-house Retrofit Application Process): Trial and delivery of a whole-house retrofit process and toolkit 2022

Final report

30th March 2022

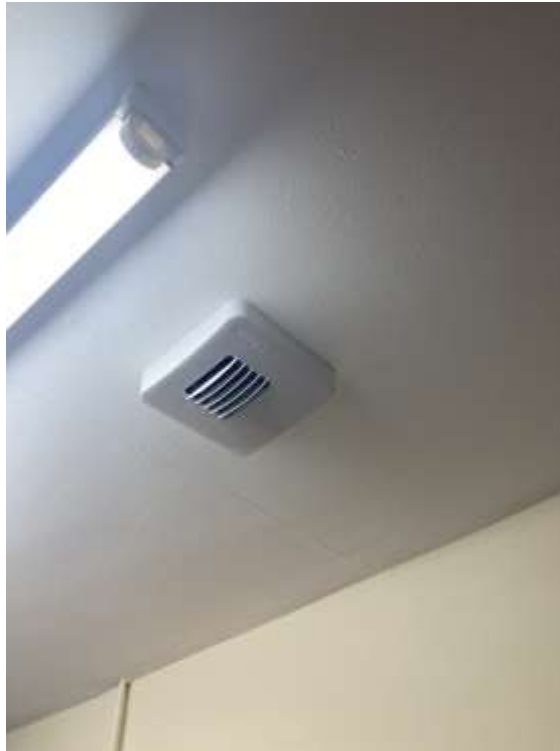
Figure 6 Centralised RH controlled ventilation in central landing

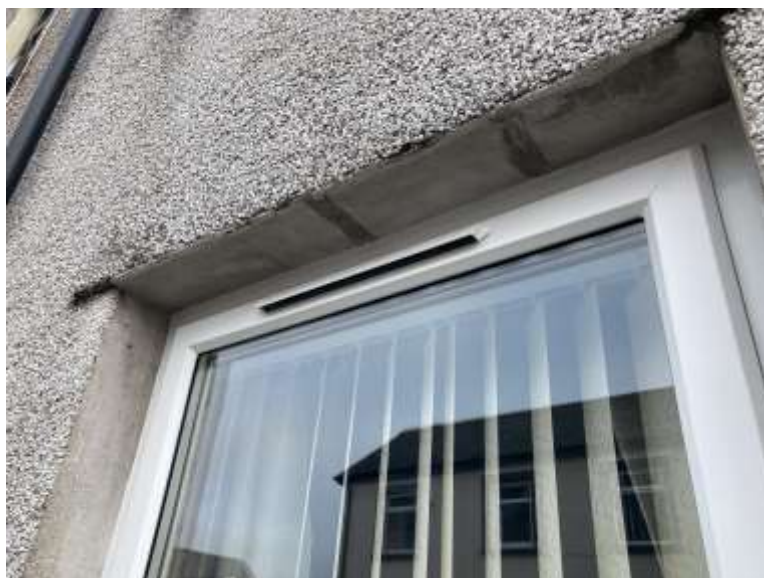
Figure 7 Balanced RH controlled trickle vent in habitable room

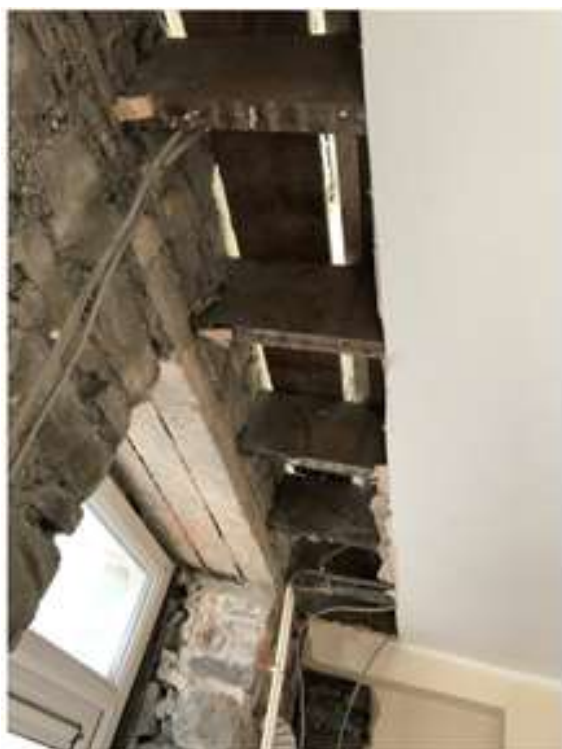
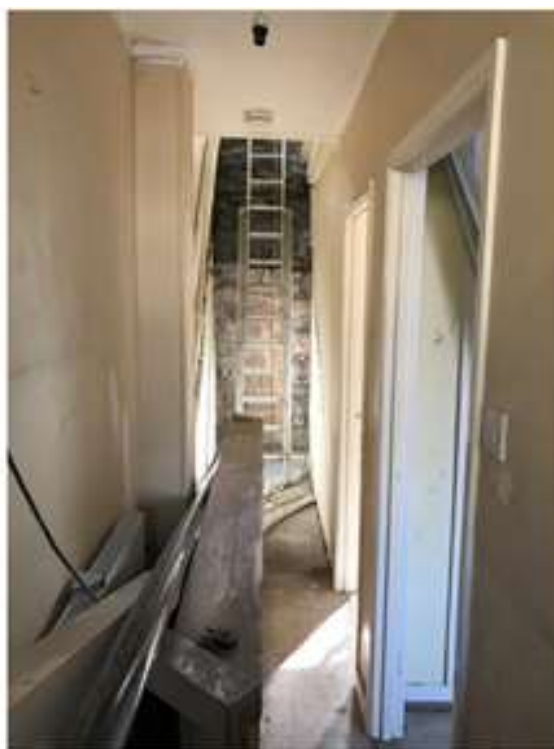
Figure 11 Enabling work required access to interfloor area and behind stairwell

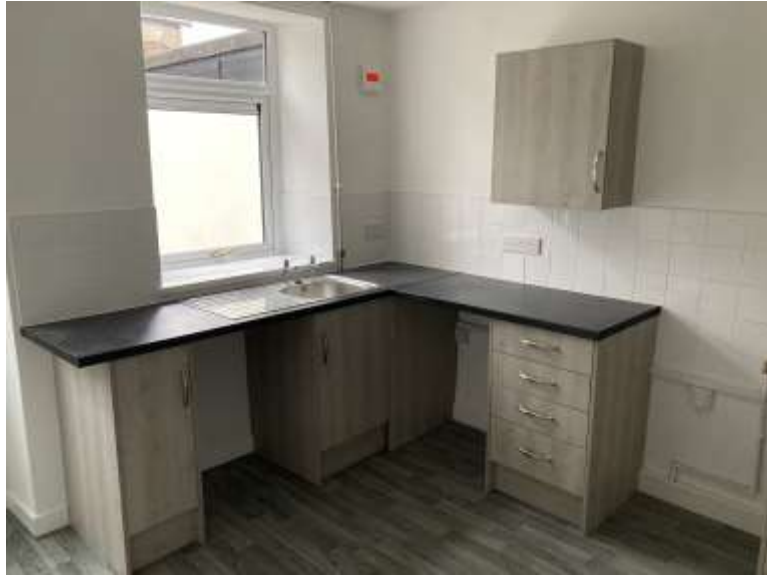
Figure 12 New units installed. Also note re-instated splay to window reveals

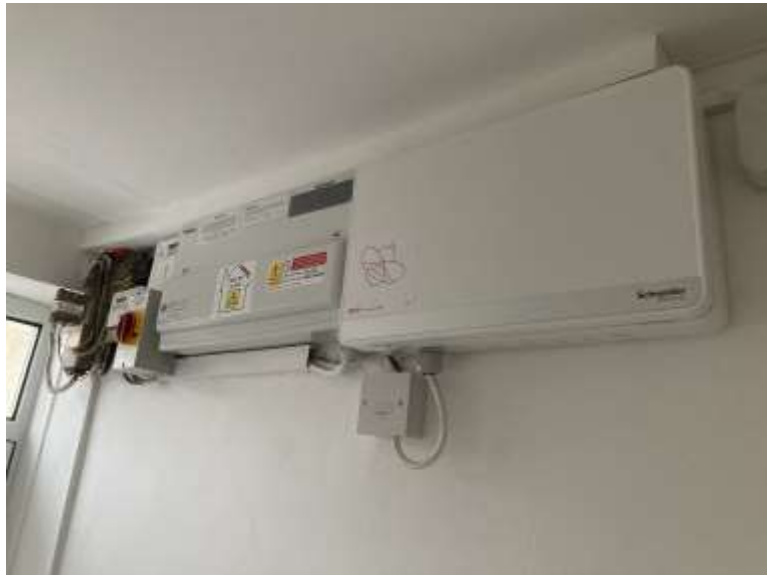
Figure 13 New fuseboxes and services for PV / battery / Monitoring

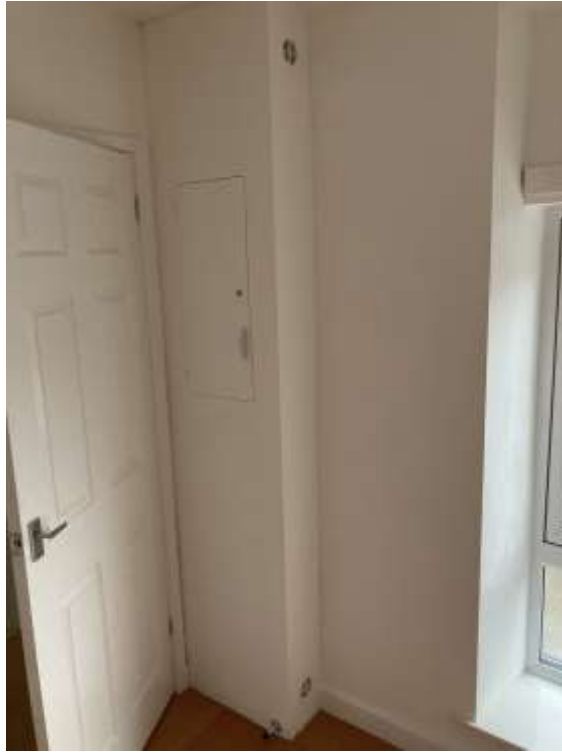
Figure 14 Monitoring cupboard in FF rear bedroom. IWI painted with breathable paint

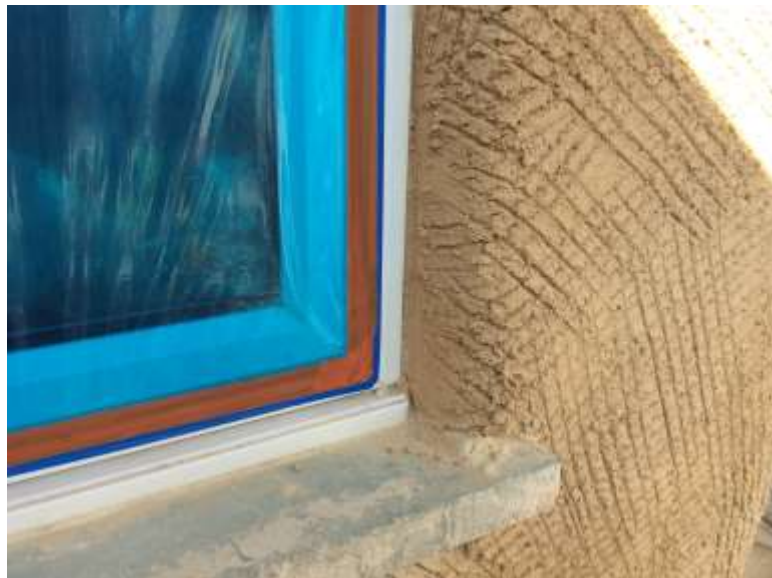
Figure 17 Air lime render scratch coat, note rounded corners to minimise risk of damage

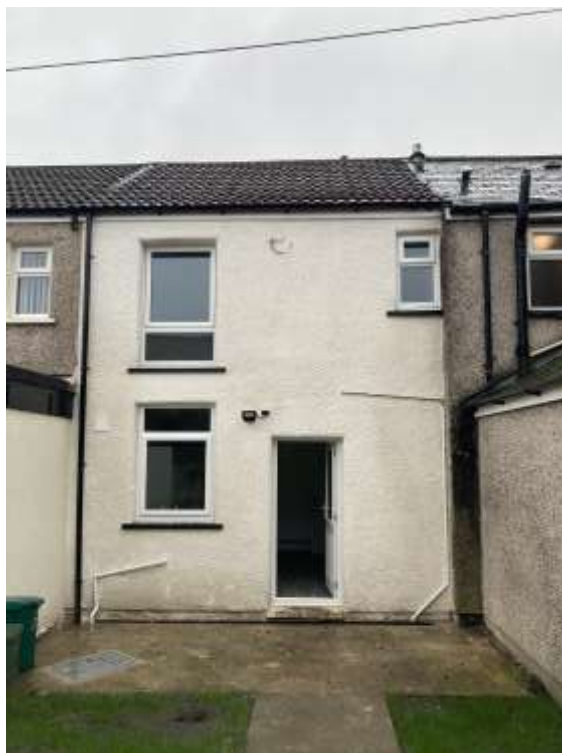
Figure 19 Rear of property with air lime render and limewash finish. note land drain

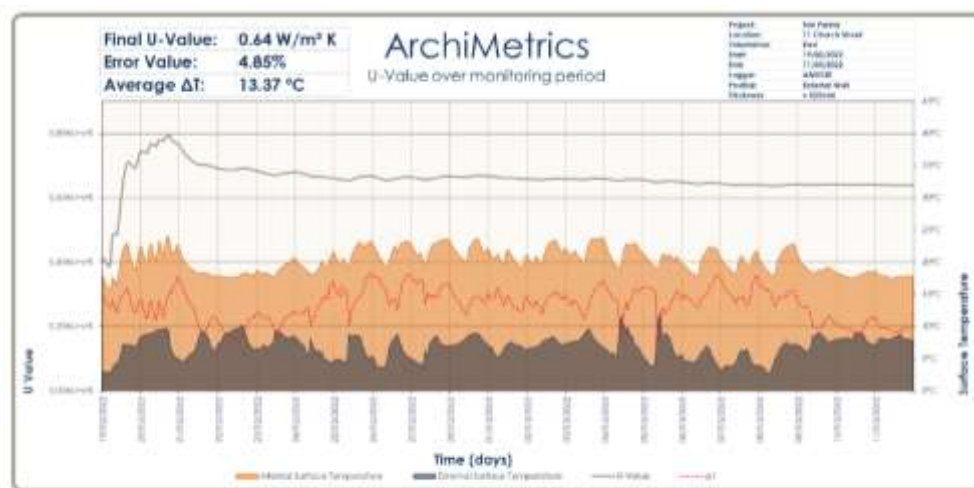
Initial reports indicate that the IWI has improved the wall's thermal performance to a U value of 0.64 W/m²K, which is in line with the original specification and expectation.

Figure 2. Measured in situ U-value, February – March 2022, Church Street, Ton Pentre.

Figure 22 U value calculations from Archimetrics report

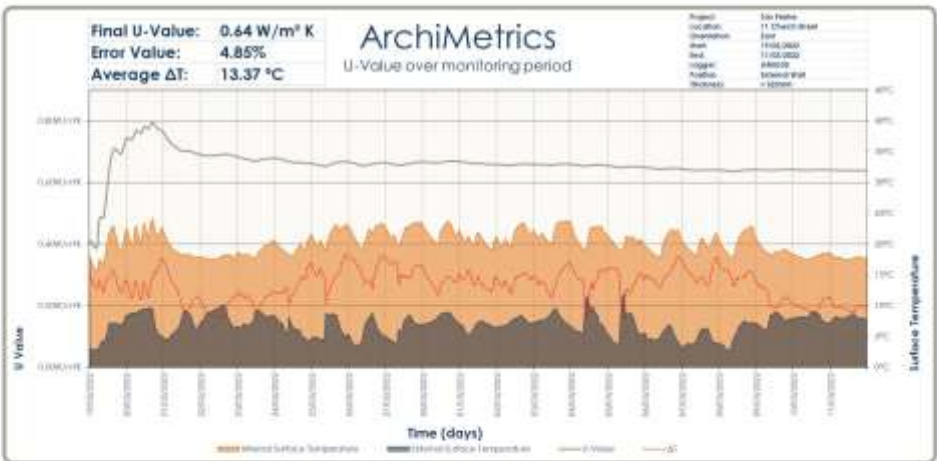
The measured in situ U-value found for the east facing 525 mm insulated stone wall at Church Street is **0.64 W/m²K** (Figure 2). As above, it should be borne in mind that construction moisture added to the wall at the time of rendering and plastering is still present within the fabric, therefore this U-value is likely to change and be lower once the wall has dried. Thus, this U-value should be seen as an interim, early-stage indication of the overall heat loss (thermal transmissivity) of this wall assembly.

Figure 2. Measured in situ U-value, February – March 2022, Church Street, Ton Pentre.
